Test report no. 81737/08-I

Test: Testing and classification of window profiles
made of PVC-U according to BS EN 12608: 2003

System: Euroslide

Designation of profile: Frame 3, Art. 500023

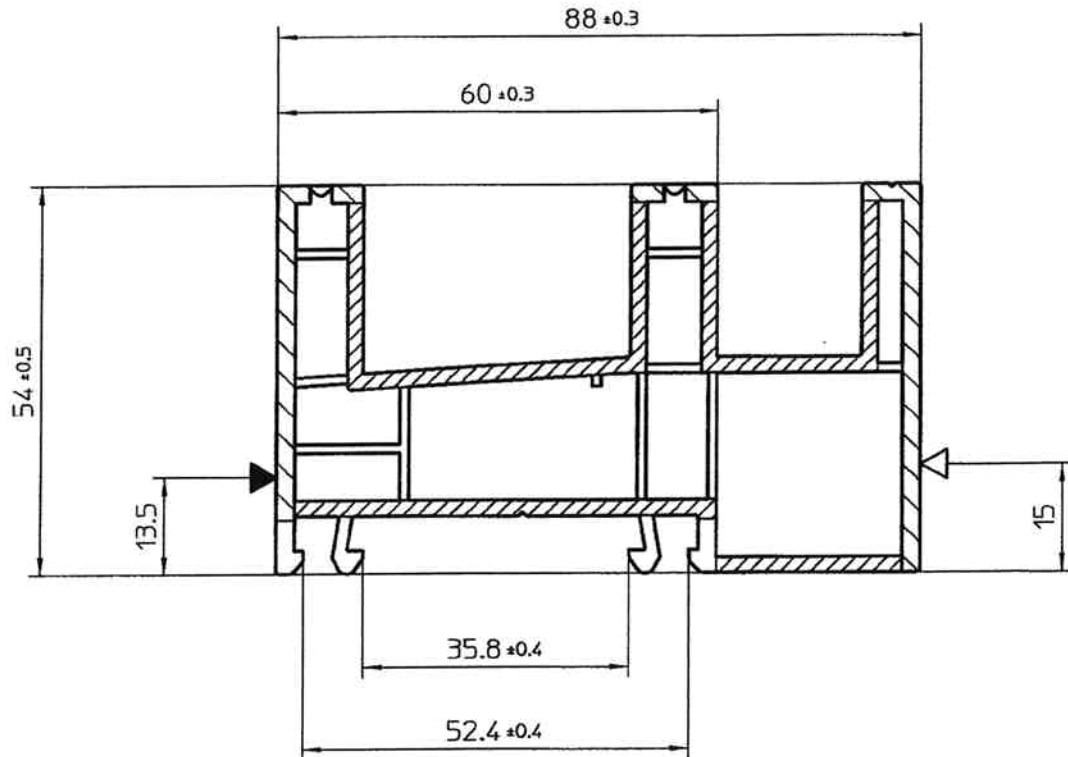
Profilbezeichnung: Frame 3; Art.500023

Metergewicht: 1.33 kg/m

Schweißleistung beim Systemhersteller: $F_{soll} = 3756 \text{ N}$

Eckbruchwert für Fensterfertigung: $F_{soll} = 2705 \text{ N}$
